Wall Erosion and Failure:

The same as other historic buildings, Tous wall could not be safe from decay. The failures observed on the wall are as follows (Nasseh, 2010):

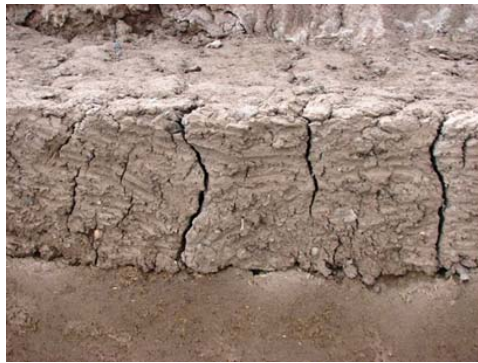
Fig. 4: Failure induced by water penetration down upward on Tous wall.

Failure induced by upward water infiltration (Fig. 4): High ground water table can cause such failure but Tous region has a low ground water table. It seems that the main factor which has led to such failure is the lack of a convenient drainage system at the bottom of the wall. Run-off water can penetrate into the wall and consequently induces different cracks at its bottom. Applying a proper drainage system can reduce the consequences of run-off water.

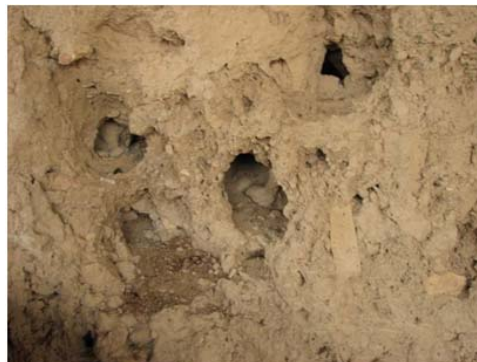
Fig. 6: Failure induced by rat activities on Tous wall.

Failure induced by rat and termite activities (Fig. 6): Termites can survive in places with sufficient water and organic matter such as straw. Small animals leave less evidence of their depredations but can be more damaging. In the region, termites have created burrows through the wall structure. These burrows can provide a suitable place for water infiltration and also can cause the loss of wall bearing capacity. The same but much larger burrows have been created by rats in the wall. Animals contribute actively to the decay of earth structures but of all erosive agencies, they are the most easily controlled. Rats can be controlled by using traps and special poisons. There are special poisons for reducing termite population too. Moreover, physical and chemical protectors can be useful (Ghayoorfar *et al.*, 2008).

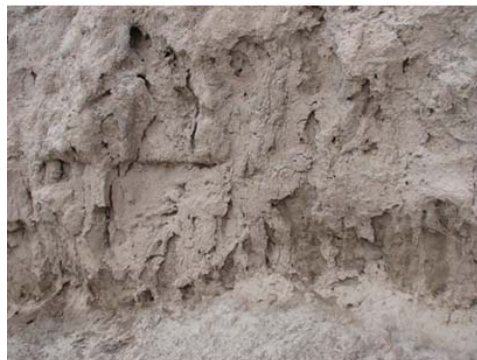
Fig. 7: Failure induced by wind accompanied by rain on Tous wall.

Failure induced by wind accompanied by rain (Fig. 7): Wind can cause rain drops erode the wall surface. This problem can also be decreased by a resistant coating or covering.
